Manhole Inspection Summary

Manhole # S45E__006MH

Insp Date: **7/24/08 8:27 AM**

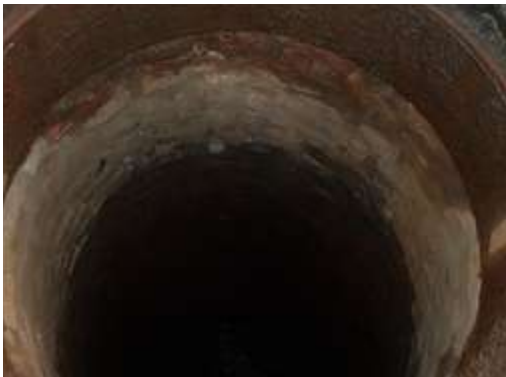
Defect 2

☒ **Leaks**

Frame Leaks

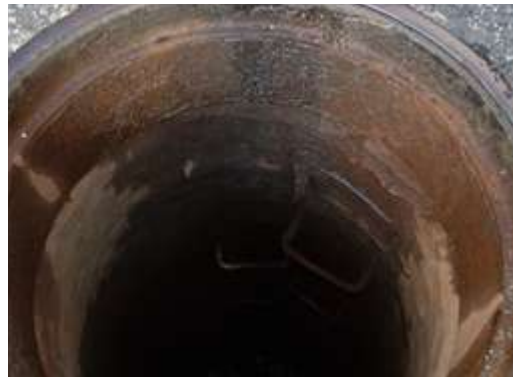
Defect 1

Condition: ☐ Sound ☐ Cracked ☐ Root Intrusion ☒ **Loose Brick** ☐ Deteriorated

Infiltration: ☐ None ☐ Joint ☐ Cracks ☒ **Mortar** ☐ Roots ☐ Wall

Infiltration

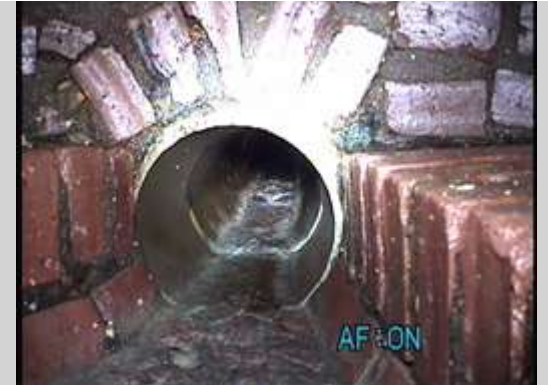
12 O'Clock Outflow

8 in. Circular Gravity Sewer
Pipe Out @ 12 O'Clock

Pipe Height: **8.4** (in.) Rod and Bar (Angled)
Pipe Material: **Clay** ☐ Pipe Lined
Invert Depth: **13.35** (ft.) Flow Characteristics: **Fast**
Deposits: ☒ None ☐ Mud ☐ Sludge ☐ Debris ☐ Grease
Silt Depth: (in.) Deposits Extent:
Infiltration: **None** Pipe Seal Cond: **Sound**

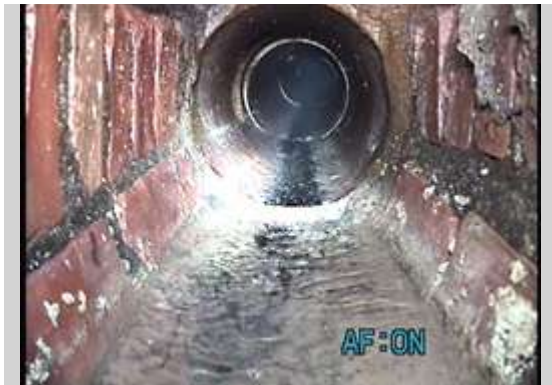
6 O'Clock Inflow

8 in. Circular Gravity Sewer
Pipe In @ 6 O'Clock

Pipe Height: **8.4** (in.) Rod and Bar (Angled)
Pipe Material: **Clay** ☐ Pipe Lined
Invert Depth: **13.20** (ft.) Flow Characteristics: **Fast**
Deposits: ☒ None ☐ Mud ☐ Sludge ☐ Debris ☐ Grease
Silt Depth: (in.) Deposits Extent:
Infiltration: **None** Pipe Seal Cond: **Sound**

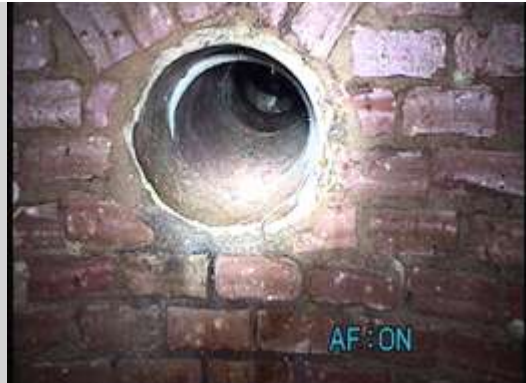
9 O'Clock Inflow

Pipe In @ 9 O'Clock

Infiltration: **None** Pipe Seal Cond: **Sound**

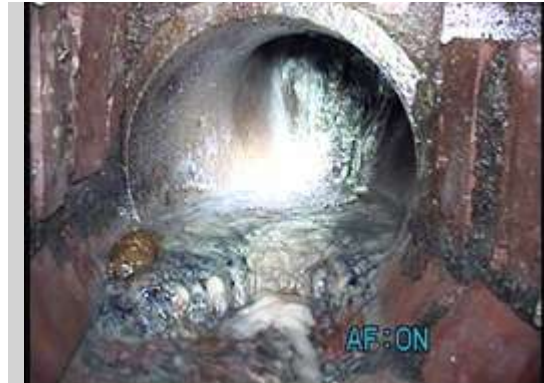
Drop In @ 9 O'Clock

Drop: **Inside**

Drop Condition: **Open**
